REVISITTING RAPID RECOVERY AND REPAIR

**Florian Laux, REFKO Feuerfest GmbH,
revisits the performance of a lining
technology that has been used to repair
cement kilns in a number of different plants.**

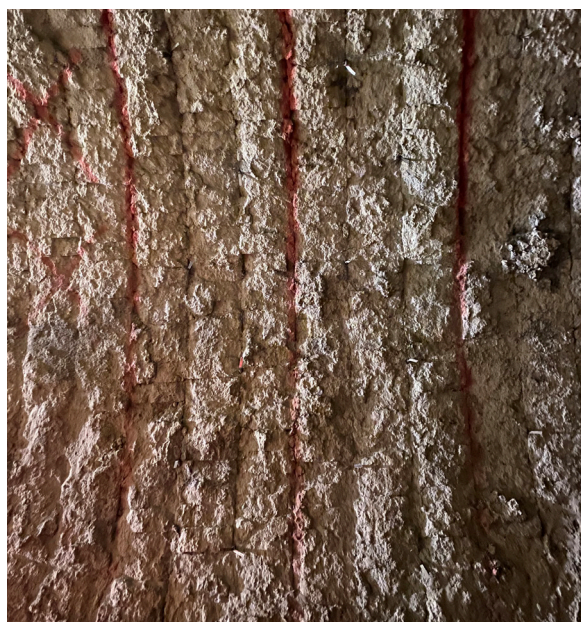
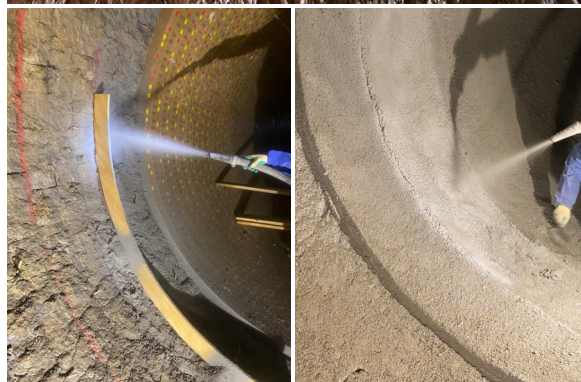
North Rhine-Westphalia: (top) old brickwork, almost dust-free gunning with field classification. (Bottom) final result after installation.

Good adhesion with the old brick lining was achieved right from the start. In each case, whole quarters were sprayed in the corresponding lining width. After initial stiffening, the kiln was rotated, and quarter after quarter was sprayed. For the lining of an area of approximately 38 m³, a time of approximately 12 hours was required. After 24 hours of drying, the kiln was started up with the plant-specific heating-up curve without any problems or disturbances. Regular thermal imaging camera shots of the lining area were inconspicuous over the entire run time, which in any case indicated that there was no major damage to the lining. Even afterwards, during the main inspection, a residual thickness of the spray lining with REFKO Recovery MG 78 was still visible at all points, even where only a few millimetres had been applied.

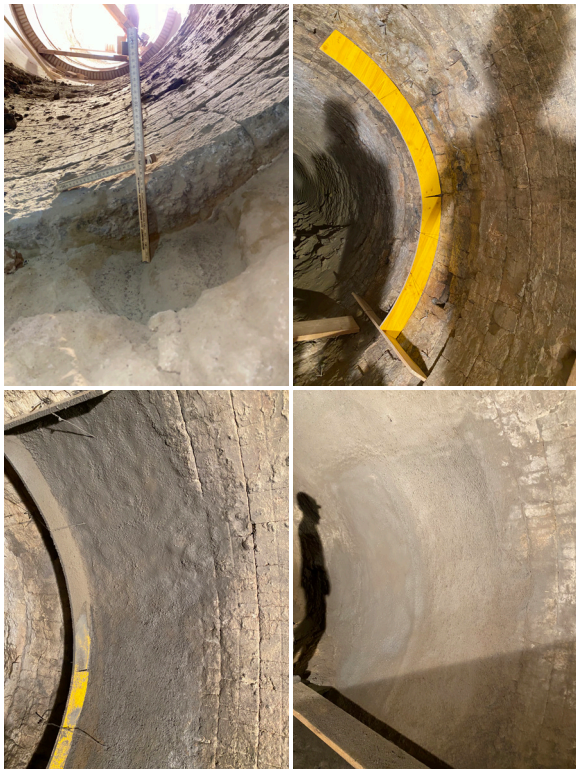
South Austria: Old masonry and discernible thickness of application, field grading, final result after installation.

A damaged area was also repaired in the burning zone. The approximately 1.4 m was divided into two sections. The refractory consumption for this area amounted to 3.5 t of gunning material. The lining, including all necessary preparatory work, took 10 hours. According to the furnace operator, the lining with bricks in this area alone would have taken at least 24 hours, plus the effort of moving the appropriate equipment into the furnace. After the completion of all the work in the kiln it was brought up to operating temperature within 36 hours. Despite an emergency shutdown of the plant in the area of the cyclones one month after lining, the kiln ran through until the scheduled inspection and showed no abnormalities. Here, too, the Recovery system can be used as a preventive measure to extend kiln downtimes until the next scheduled stop.

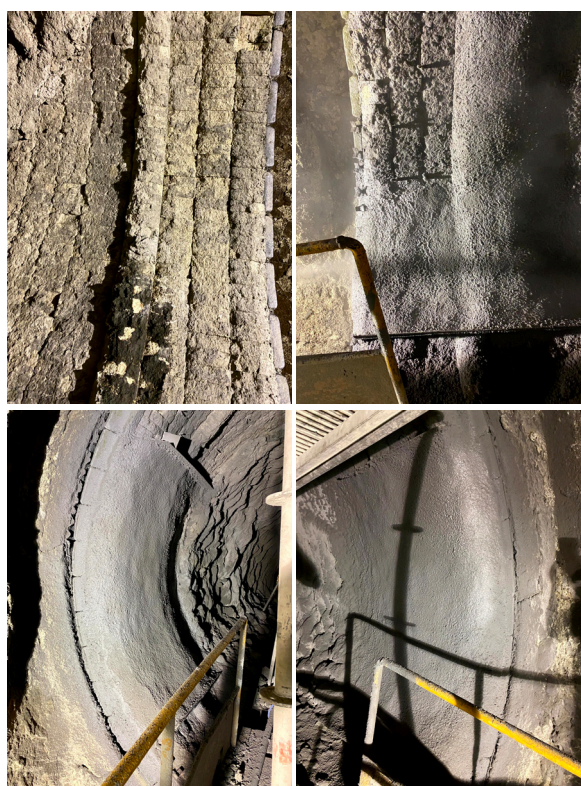
Turkey: Old brickwork outlet zone, before and after installation with REFKO Recovery MG 78.

initial trials with the REFKO Recovery MG 78 outside the EU. Here, too, the company were able to continue the series of successes. The area to be repaired has now lasted for 3 months and the factory has reported no abnormalities. Based on this, several parts in kiln 2 and kiln 3 were scheduled for repair in October 2022. The operator was enthusiastic about the opportunity for dust-free spraying, quick repair, and the possibility to heat up without a specific heating plan. In this particular case, the kiln was back up to operating temperature in less than 24 hours after the gunning work was completed. Whilst this is not a procedure that the company would want to propagate or advertise, it nevertheless shows the flexibility and properties of this unique product.

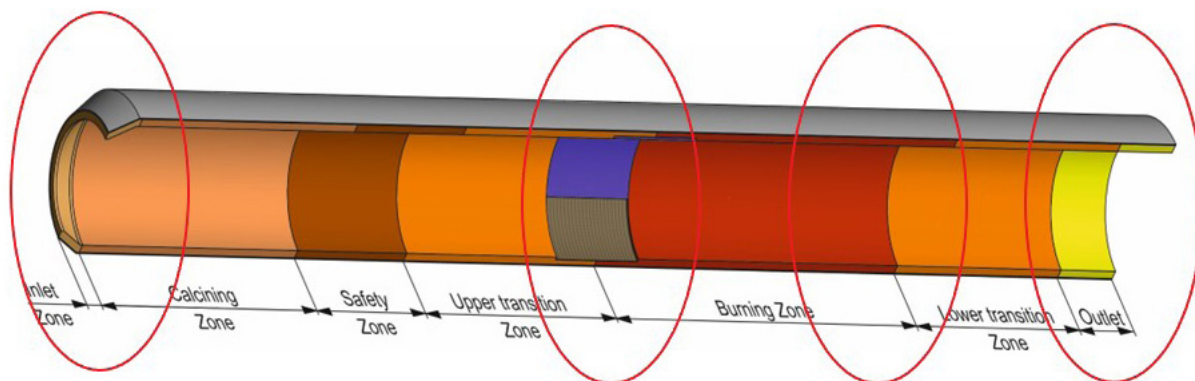
Installation areas of the previous field tests until now.
